# Cleanup and Closure at Camp Navajo

*After assuming the lead role in conducting the Resource Conservation and Recovery Act closure of munitions detonation operations at Camp Navajo in 2000, the Army National Guard is set to implement post-closure care in spring 2011.*

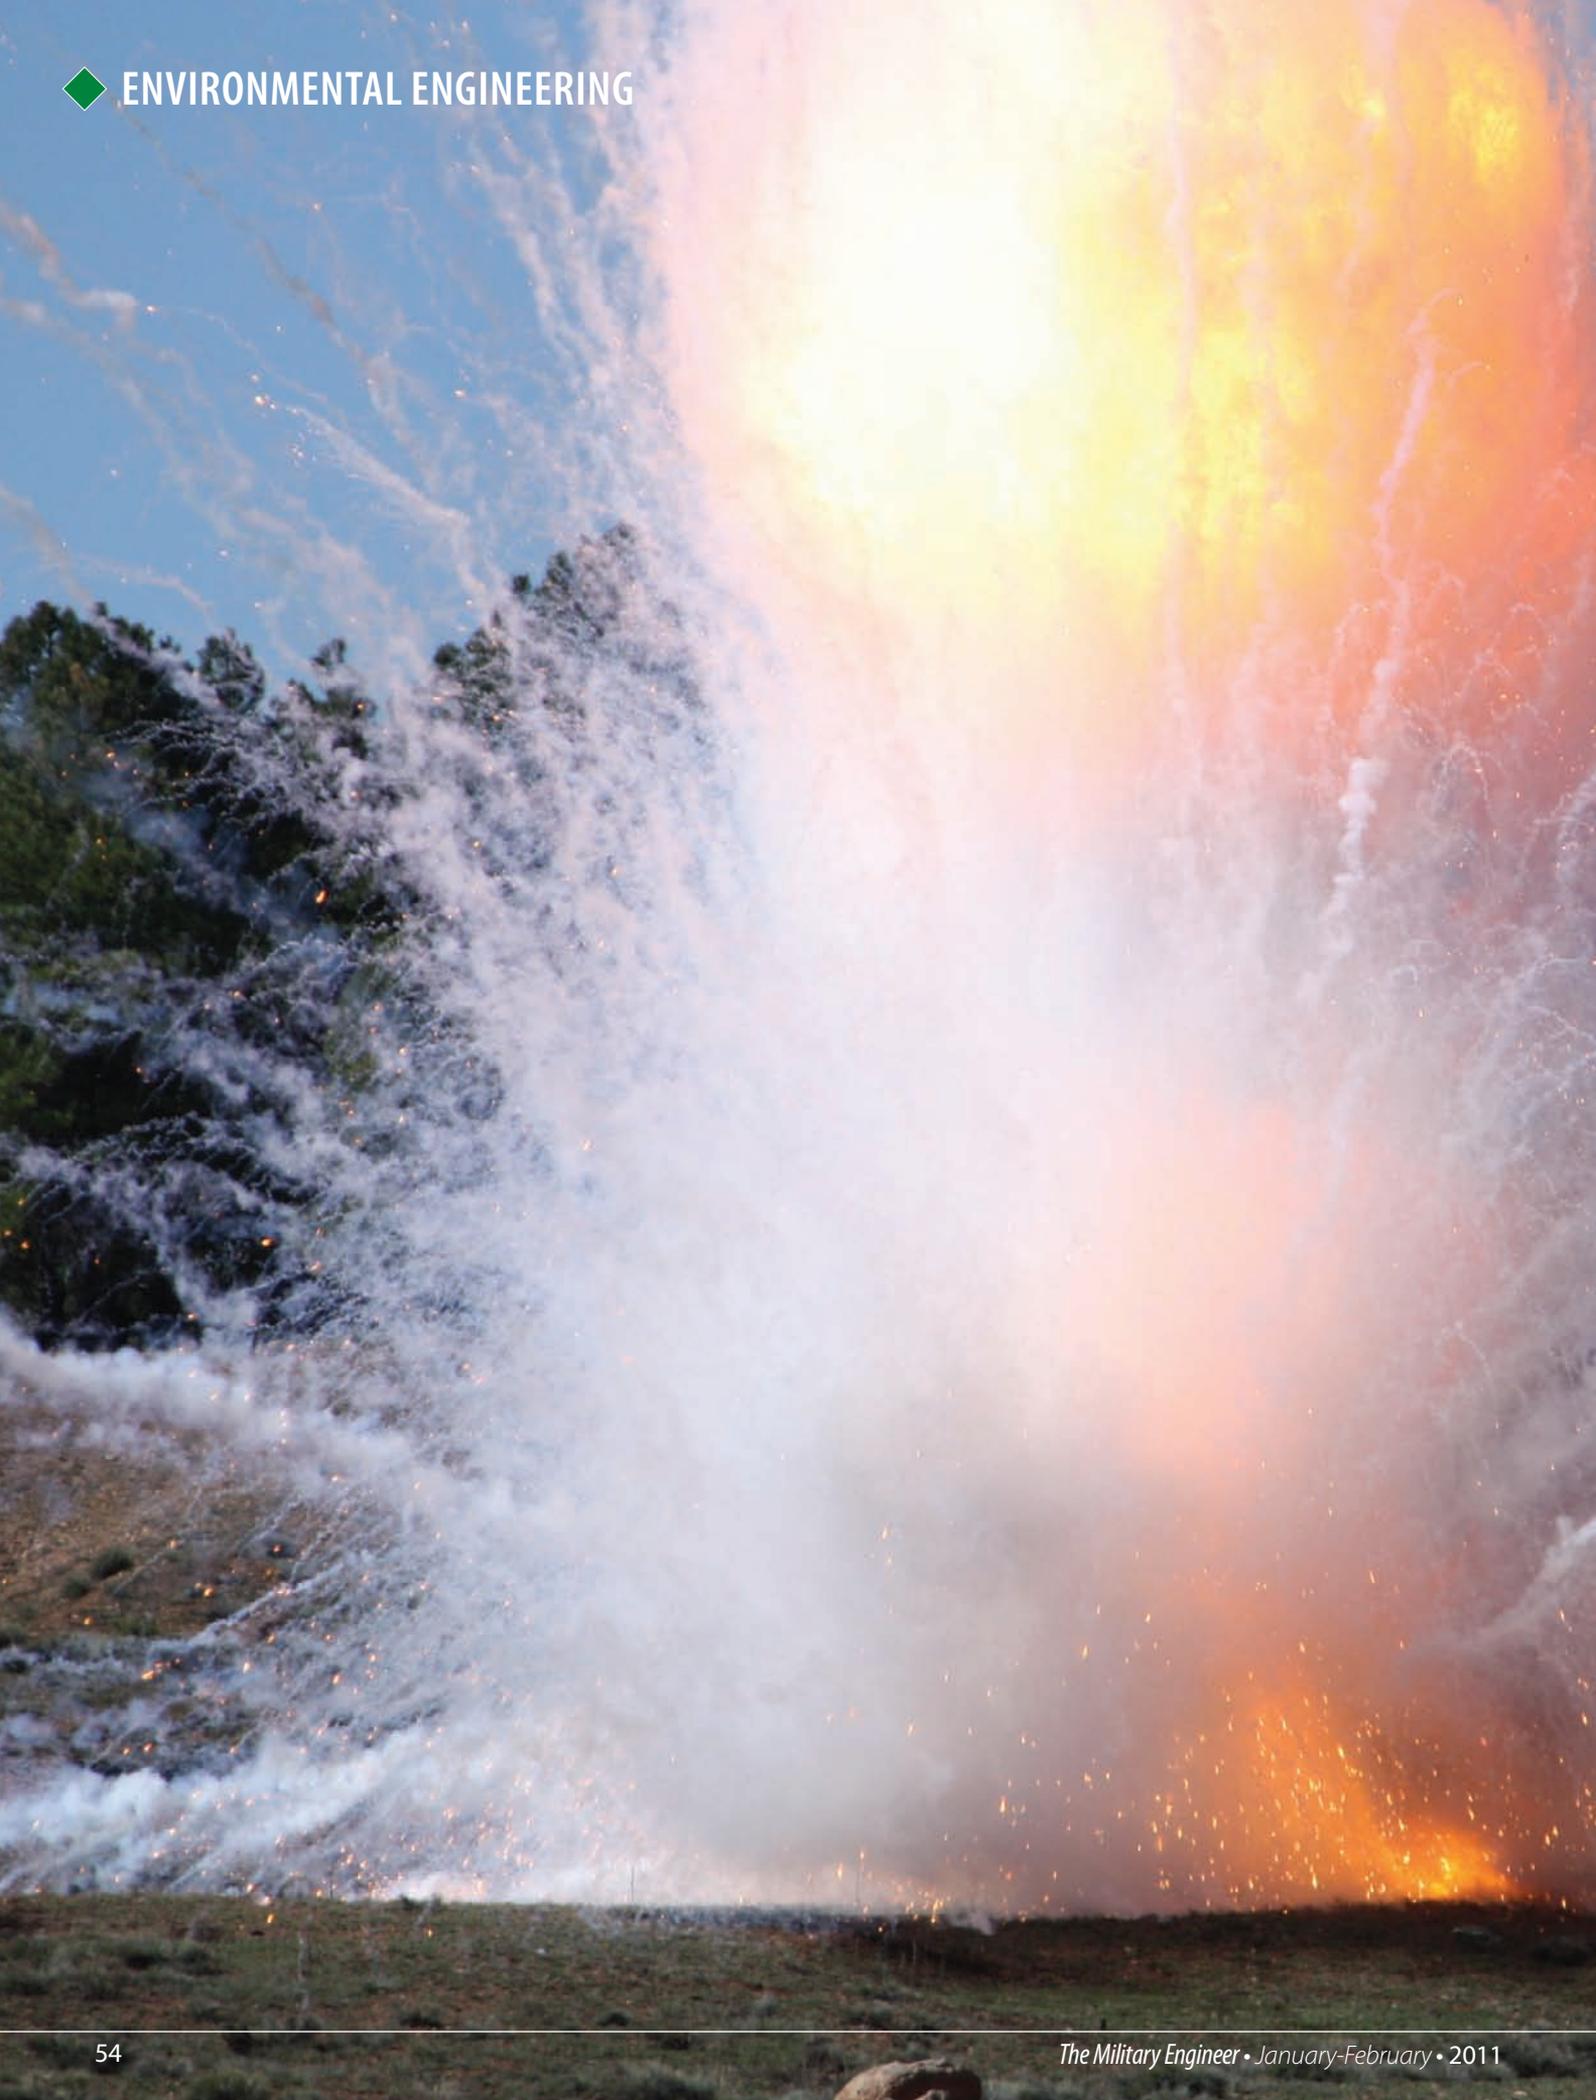
A white phosphorous 81-mm mortar is disposed of by open detonation at Camp Navajo, Ariz., in spring 2010. A total of 11,178 munitions and explosives of concern were destroyed as part of the RCRA closure project.
